Internal Report

Product and Application

Product Name : Daikacoat 2000
Facility Name : Kiln SP ID Fan

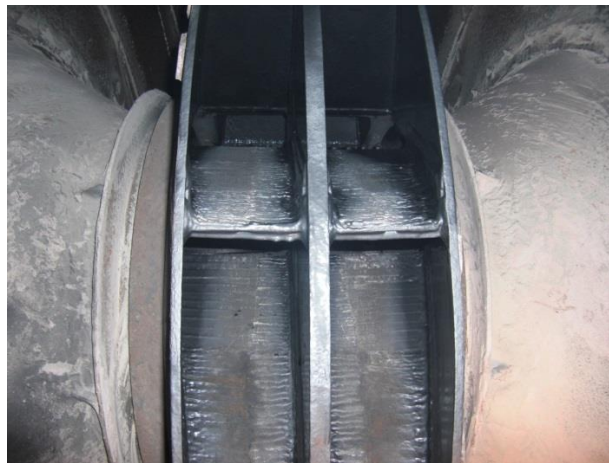
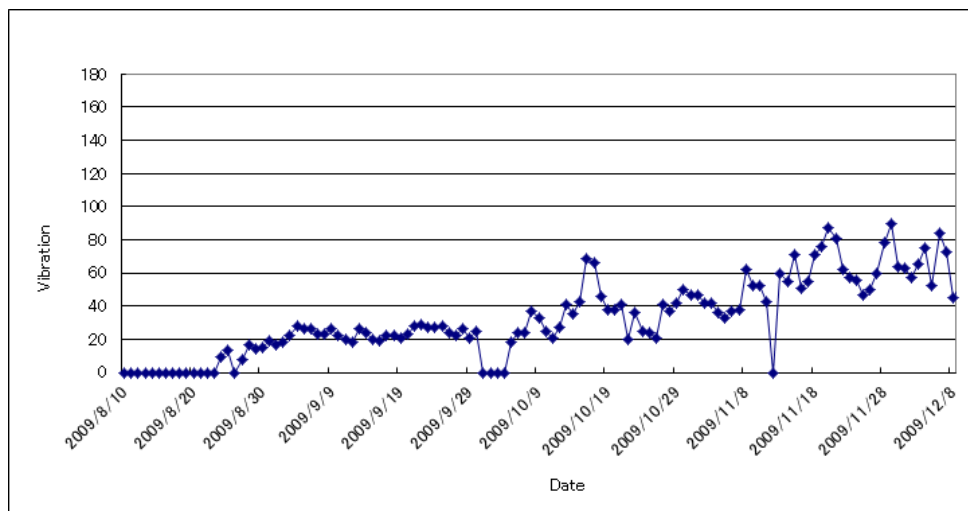
The material was built up on the fun and vibration of the fun often increased. The kiln needed to be stopped one or two time in 6 month to clean up the coating on the fun.

There was no extreme increase of the vibration and it only gradually increased but it had not reached beyond allowable level so that the kiln has not stopped within 6 month. Also, the record of the vibration indicates that the coating was sometimes dropped off by itself without any enforcement.
